FORESIGHT

NEWSLETTER CONTENTS

JULY 2021 EDITION

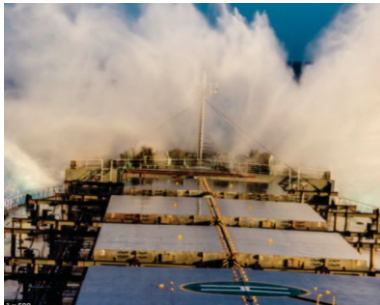
LEAKING HATCH COVER CAN CAUSE CARGO DAMAGE

When hatch covers are leaking, the rubber gaskets are the first to gain attention. Rightly so, because many problems are directly linked to their condition, and the crew may be able to change the gaskets themselves. Regrettably, however, some owners limit hatch cover attention to replacing the gaskets when worn out and miss out on the finer points of hatch cover maintenance.

Most hatch covers have movable parts like hinges, hydraulic cylinders, wheels, cleats, all exposed to wear and tear over time and having an influence on how well the hatch covers work.

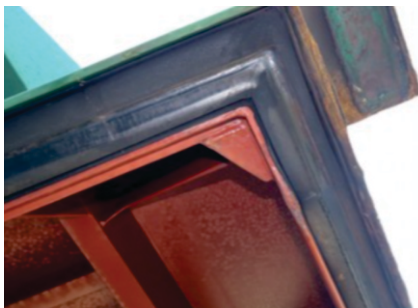
Rubber gaskets

When leakages occur, the rubber gaskets of the hatch covers are usually hard, deeply and permanently compressed, chafed or loose, and may even have sections missing. Gaskets may be of solid rubber, or have a hollow or sponge core.

The point is to have gaskets of sufficient resilience to achieve tightness when resting against compression bars of hatch coamings. The design compression for common gasket types is usually in the range of 10-15 mm, depending on the thickness. Thumb Rule is to replace the packing when a permanent impression reaches half the design value.

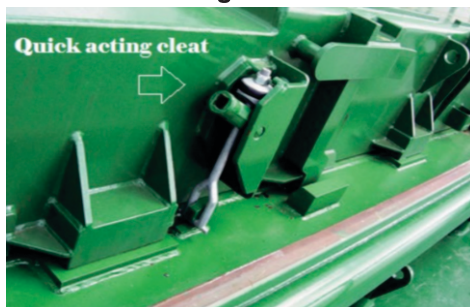
Means of securing –

There are various ways to secure the hatch covers once they are in place, depending on the type. Modern covers may be self-cleating or secured by hydraulically operated cleats or wedges, but the most common type on older vessels is the manual quick-acting cleat, having a cam at the upper end, which is forced onto a snug on the hatch cover panels.

A rubber disc between two steel washers at the lower end of the cleat has enough elasticity for the cam to be placed on the snug by using a portable lever. Thus the hatch covers are restrained from lifting, but are allowed some movement on the hatch coaming in the transverse and longitudinal directions.

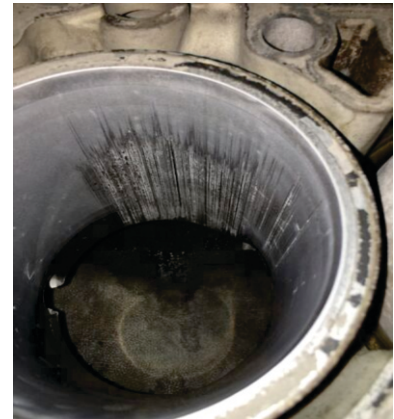
Serious Damage to the Medium speed 4-stroke Engine

The subsequent investigation alongside revealed that the metal particles found in the lubrication oil filters emanated from piston rings and piston skirts. Three pistons had almost seized. The main engine, a six cylinder medium speed type had severe damage and the following parts had to be renewed: all cylinders liners, three complete pistons, piston rings on all cylinders, all main and connecting rod bearings.

In addition, the turbo charger had to be overhauled as the nozzle ring was broken. The complete lubrication system had to be carefully cleaned and flushed. The vessel was off hire for almost two weeks.

The pistons in cylinder units' No. 1 and No. 3 were melted down in certain areas and the skirt in No. 4 was torn. Liners were scuffed as a result of the above. The cylinder lubrications channels were found clogged and so cylinder lubrication has been inactive. The lubrication oil pump was found deteriorated due to the hard impurities in the lube oil system.
